## MONITOR:DISCUSSION

# Discussion

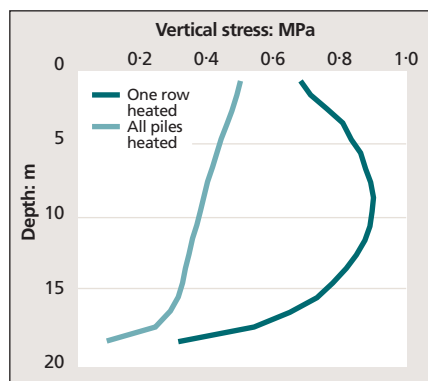
Numerical modelling of a group of piles comparing the case of one row of piles heated with the case of all piles heated (taken from a forthcoming paper by Kazangba, Dupray and Laloui)

Figure 1 from a forthcoming paper by Kazangba, Dupray and Laloui, provisionally titled 'Numerical study of a seasonal thermo-piles energy storage', compares the stresses induced in a pile when only the row of piles to which it belongs is heated with the case where the whole group of piles is heated. Considering that the stress induced in this simulation in the same pile by the mechanical load, averaged on its length, is about 3 MPa, the thermal stress is about 15% of the mechanical load when all piles are heated and about 30% of the mechanical load when only one row of piles is heated. One could therefore conclude that when a group of piles is heated the safety factor will be less affected compared to the case of one isolated energy pile. However, in the case where all the piles are heated together, the slab constraint is still present, even if less

strongly. Consequently, the reduction of the safety factor is a realistic problem which has to be considered in design practice.
